Planning Application for Residential Development of 43 Dwellings on Land at Oakhurst Rise, Cheltenham (Ref: 20/00683/OUT)

PROPOSED SITE ACCESS & INTERNAL ADOPTABLE ROAD LAYOUT

STAGE 1
ROAD SAFETY AUDIT REPORT &
MOBILITY AUDIT

# Stage 1 Road Safety Audit Report Proposed Site Access & Internal Adoptable Roads Land off Oakhurst Rise, Kings Church, Cheltenham (Updated Scheme)

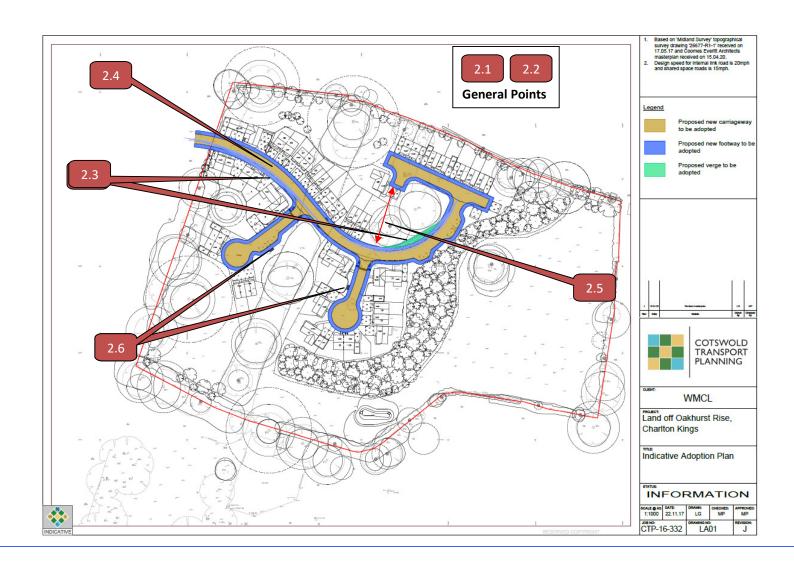
# Appendix A

Summary: Potential collisions associated with localised flooding

Drainage details have not been provided and it is therefore not possible for the Audit Team to ascertain whether or not there will be any safety issues associated surface water drainage. It is noted that the proposed vertical levels within the site may result in localised flooding if suitable drainage is not provided; this could increase the risk of loss of control collisions or cause a hazard for non-motorised users, particularly during icy conditions.

Summary: Collisions associated with poor illumination

No details relating to the provision of street lighting have been provided. The absence of street lighting could increase the risk of vehicle collisions during the hours of darkness.

Summary: Potential collisions associated with poor forward visibility

The vehicle track plots for refuse vehicles negotiating the internal estate road junctions indicate that forward visibility on the approaches to bends can be achieved. However no further details have been provided, consequently any obstructions in forward visibility may increase the risk of head on or side swipe vehicle collisions.

Summary: Potential speed related collisions associated with downhill gradient *Location: Main Internal Spine Road*

It is acknowledged that a departure from standards for the internal estate road gradient has been granted, however there is concern that the downhill gradient on the main road serving the proposed development may induce higher vehicle speeds. This could increase the risk of speed related collisions and collisions with other road users.

Summary: Potential risk of pedestrian trip/slip/fall injuries Location: Eastern cul-de-sac connection to Oakhurst Rise

The layout of the eastern cul-de-sac serving properties 25 to 29 provides no direct pedestrian connection to the main access road and Oakhurst Rise and, as a result, pedestrians are expected to circumnavigate the internal road network. It is anticipated that residents of these properties may take a more direct route through the open green area between the cul-de-sac and the main access road. The absence of a safe path may result in potential trip/slip/fall injury to pedestrians

Summary: Potential risk of pedestrian crossing at unsafe location *Location: Southern cul-de-sacs along spine road*

The scheme drawings indicate that tactile paving is to be provided on the eastern side of the cul-de-sac serving plots 7 to 10 and on the eastern side of the cul-de-sac serving plots 13 to 19. It is anticipated that the provision has been made for pedestrians to access the green open space between the respective cul-de-sacs. However, the location of the tactile paving may encourage pedestrians to cross the road at unsafe locations where the risk of pedestrians being struck by passing traffic will be greater.

It is recommended that the detailed design incorporates adequate surface water drainage to mitigate localised flooding/ponding.

Review the provision of street lighting throughout the scheme, ensuring that lighting columns are placed to avoid vehicles striking them or cause an obstruction for pedestrians using the footway.

It is recommended that forward visibility splays on the approaches to bends and junctions within the estate roads are not compromised by vegetation and boundary fencing.

It is recommended that speed reducing measure(s) should be provided along the main estate road (the section between Oakhurst Rise and properties 35 and 40 fronting the estate road).

It is recommended that a footpath link through the open green area between the cul-de-sac serving properties 25-29 and the main access road should be provided.

The tactile paving should be removed, the layout and location of the footpath link through the open green area between the cul-de-sacs should be reviewed and amended to ensure pedestrians can safely access the wider footway network.

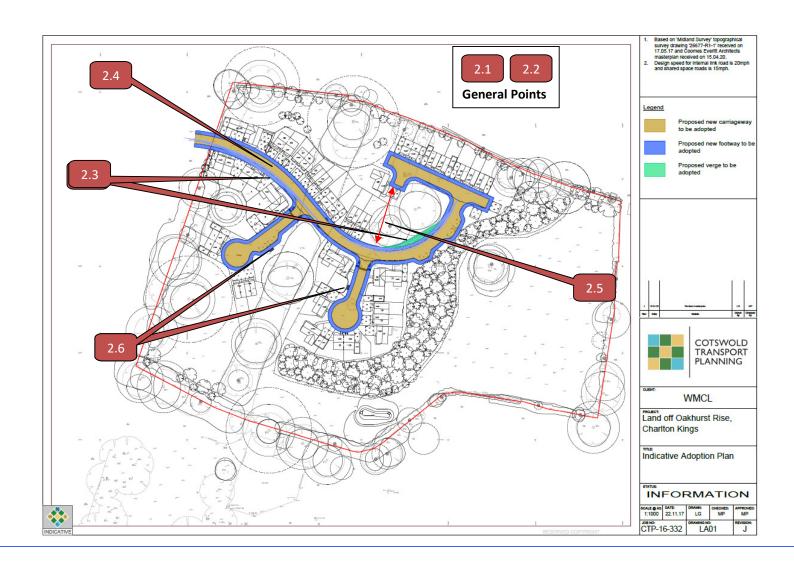
# Appendix A

Summary: Potential collisions associated with localised flooding

Drainage details have not been provided and it is therefore not possible for the Audit Team to ascertain whether or not there will be any safety issues associated surface water drainage. It is noted that the proposed vertical levels within the site may result in localised flooding if suitable drainage is not provided; this could increase the risk of loss of control collisions or cause a hazard for non-motorised users, particularly during icy conditions.

Summary: Collisions associated with poor illumination

No details relating to the provision of street lighting have been provided. The absence of street lighting could increase the risk of vehicle collisions during the hours of darkness.

Summary: Potential collisions associated with poor forward visibility

Summary: Potential risk of pedestrian crossing at unsafe location *Location: Southern cul-de-sacs along spine road*

The scheme drawings indicate that tactile paving is to be provided on the eastern side of the cul-de-sac serving plots 7 to 10 and on the eastern side of the cul-de-sac serving plots 13 to 19. It is anticipated that the provision has been made for pedestrians to access the green open space between the respective cul-de-sacs. However, the location of the tactile paving may encourage pedestrians to cross the road at unsafe locations where the risk of pedestrians being struck by passing traffic will be greater.

It is recommended that the detailed design incorporates adequate surface water drainage to mitigate localised flooding/ponding.

Review the provision of street lighting throughout the scheme, ensuring that lighting columns are placed to avoid vehicles striking them or cause an obstruction for pedestrians using the footway.

It is recommended that forward visibility splays on the approaches to bends and junctions within the estate roads are not compromised by vegetation and boundary fencing.

It is recommended that speed reducing measure(s) should be provided along the main estate road (the section between Oakhurst Rise and properties 35 and 40 fronting the estate road).

It is recommended that a footpath link through the open green area between the cul-de-sac serving properties 25-29 and the main access road should be provided.

2.2	Review the provision of street lighting throughout the scheme, ensuring that lighting columns are placed to avoid vehicles striking them or cause an obstruction for pedestrians using the footway.	Recommendation accepted. A detailed street design will be produced as part of the post-planning design and issued for a Stage 2 RSA

2.3	It is recommended that the forward visibility splays on the approaches to bends and junctions within the estate roads are not compromised by vegetation and boundary fencing.	Recommendation accepted. Forward visibility splays will be kept free of any potential obstructions. The splays as shown are either within the proposed footway or within the root protection area of a retained tree where no development is proposed.

2.4	It is recommended that speed reducing measure(s) should be provided along the main estate road (the section between Oakhurst Rise and properties 35 and 40 fronting the estate road).	have been amended to show a traffic calming

2.5	A footpath link through the open green area between the cul-de-sac serving properties 25-29 and the main access road should be provided.	The levels in the area where the footpath has been recommended would mean that the gradient would be unsuitable and levels cannot be altered due to root protection requirements. The proposed footway adds only approximately 50m to the direct line and provides a safe and suitable pedestrian link. As the risk level is assessed as low and with these mitigating factors an exception is therefore requested.
